TRANSPORTATION RESEARCH CENTER

**ON-SITE PASSIVE BELT INVESTIGATION**

CASE NO. - 96-23  
FLEET - PRIVATE VEHICLE  
LOCATION -  
ACCIDENT DATE - 1996

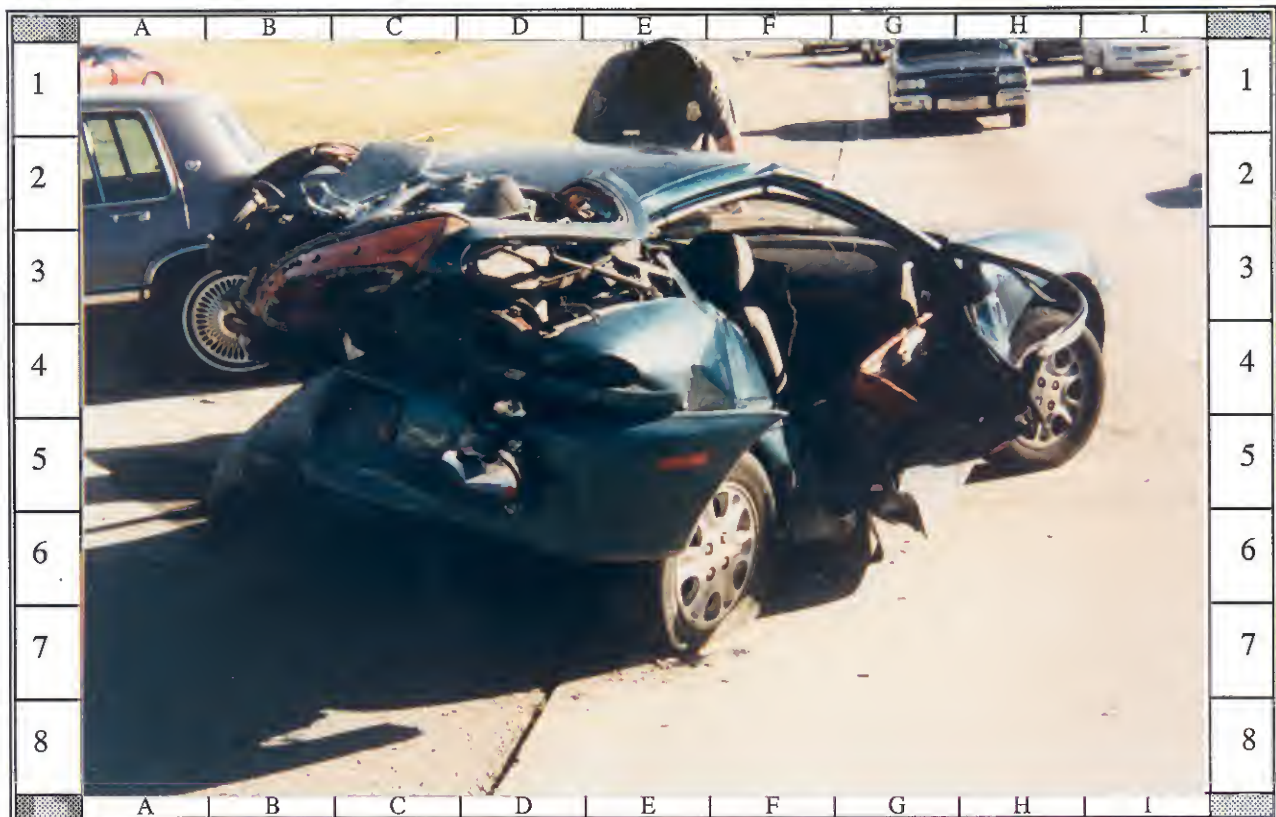
# 11: On-scene northeast view of Case Vehicle at final rest, heading southwest, straddling east shoulder & outside northbound lane after extrication of both occupants

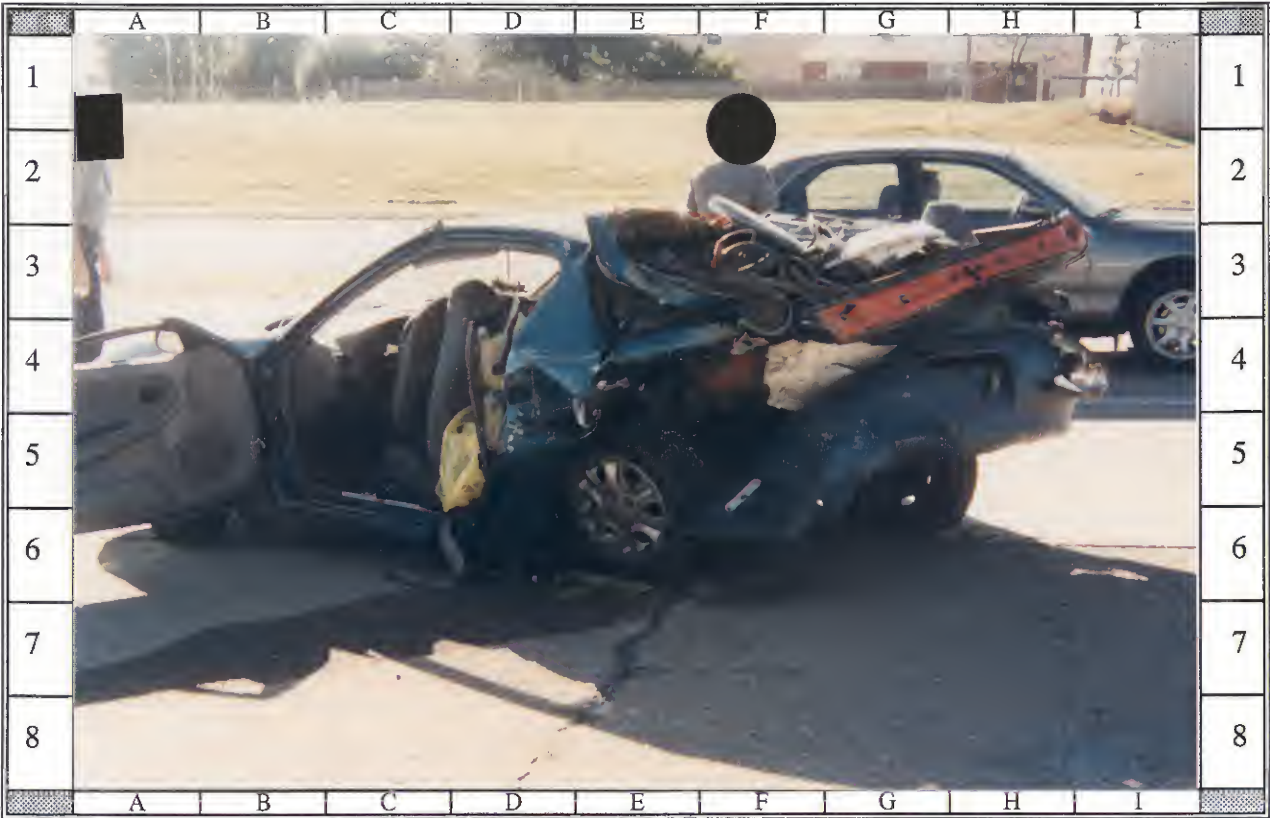
# 12: On-scene southward view at Case Vehicle at final rest, heading southwest, straddling east shoulder and outside northbound lane; NOTE: severe back damage

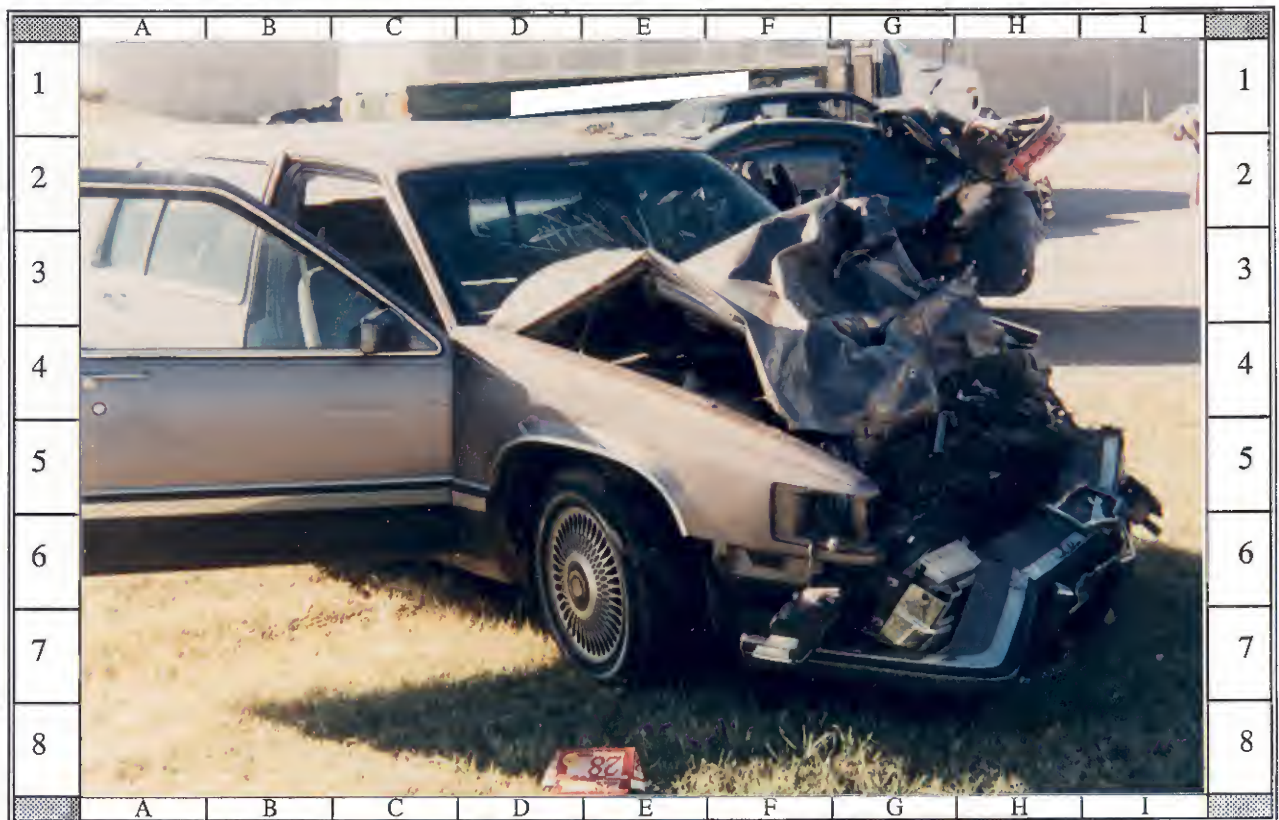
# 14: On-scene southwest view of Vehicle #2's damaged front at final rest heading east-northeast

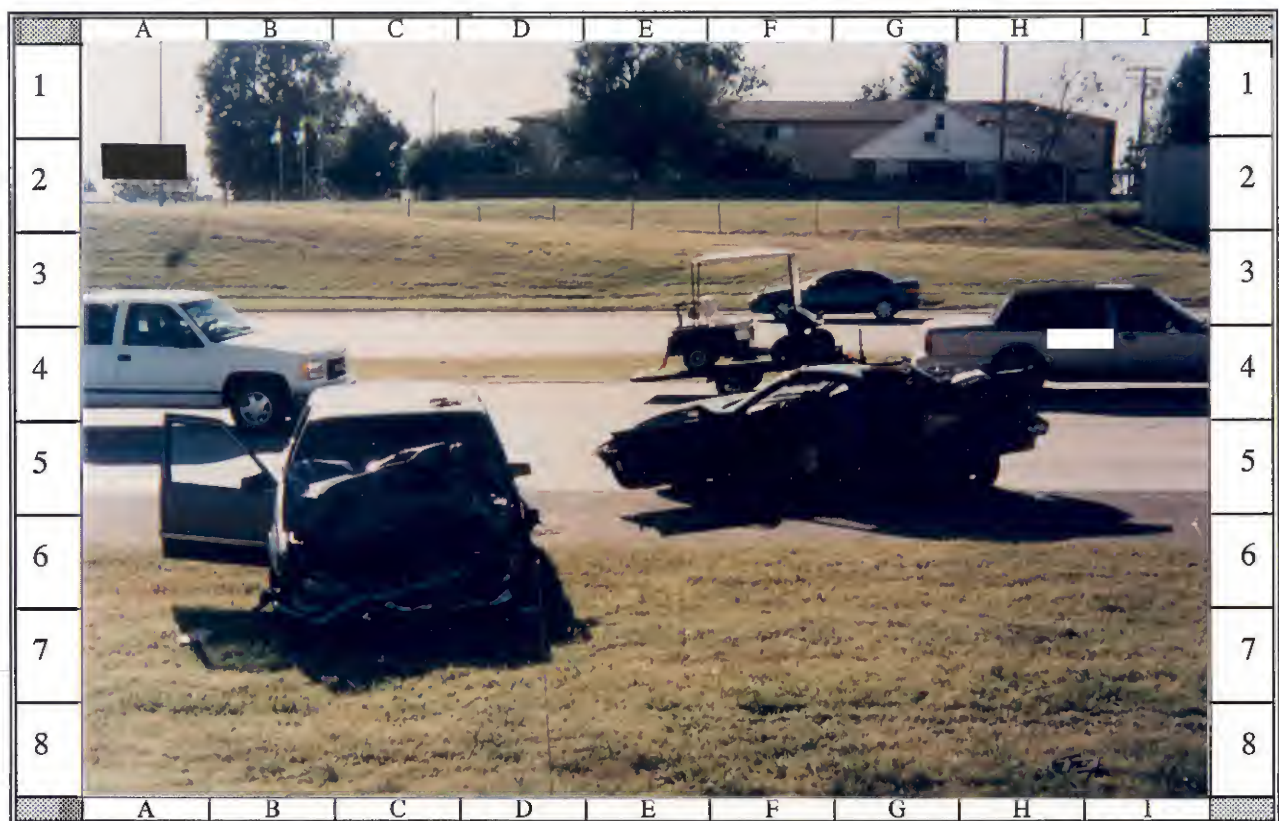
# 15: On-scene west-northwest view of Vehicle #2's damaged front at final rest heading east-northeast

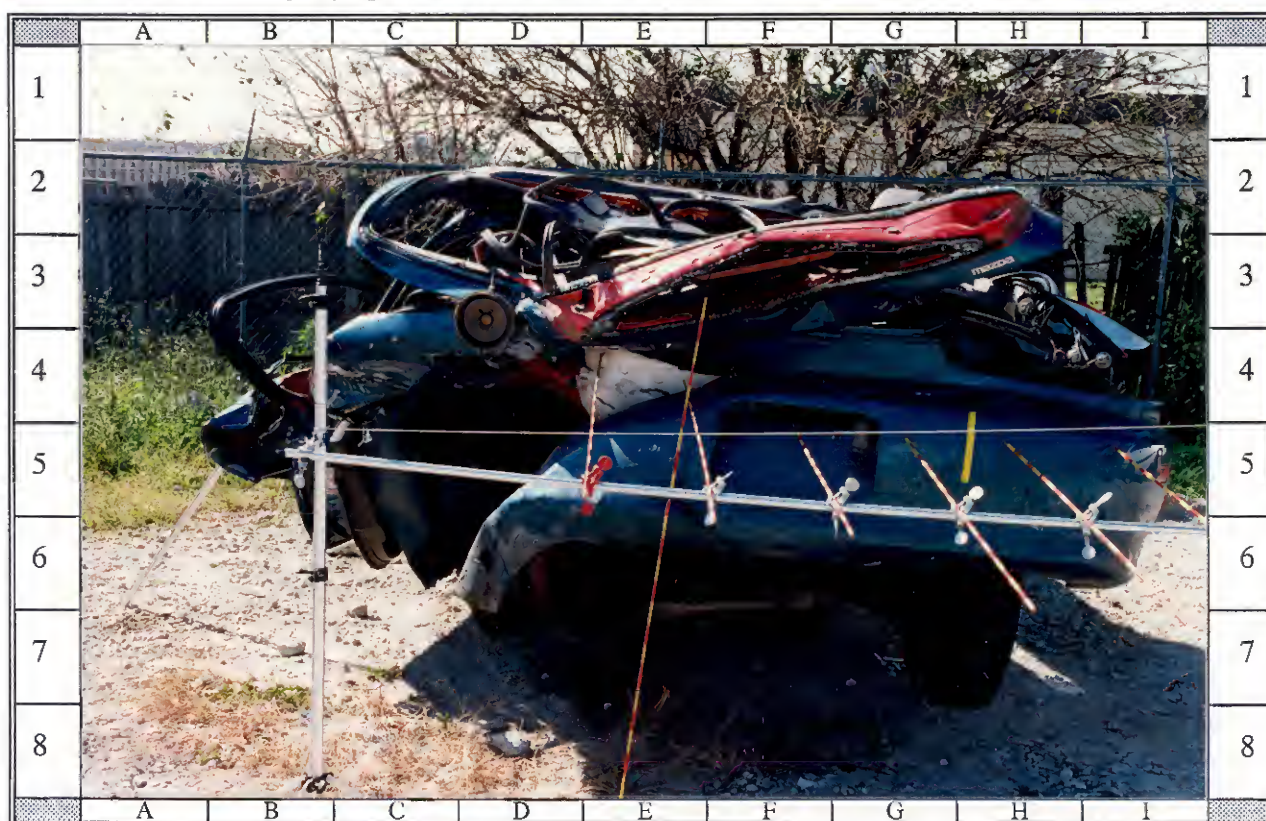
# 25: Case Vehicle's damaged back view from approximately 30 left of back without contour gauge present; NOTE: deformed left rear wheel assembly

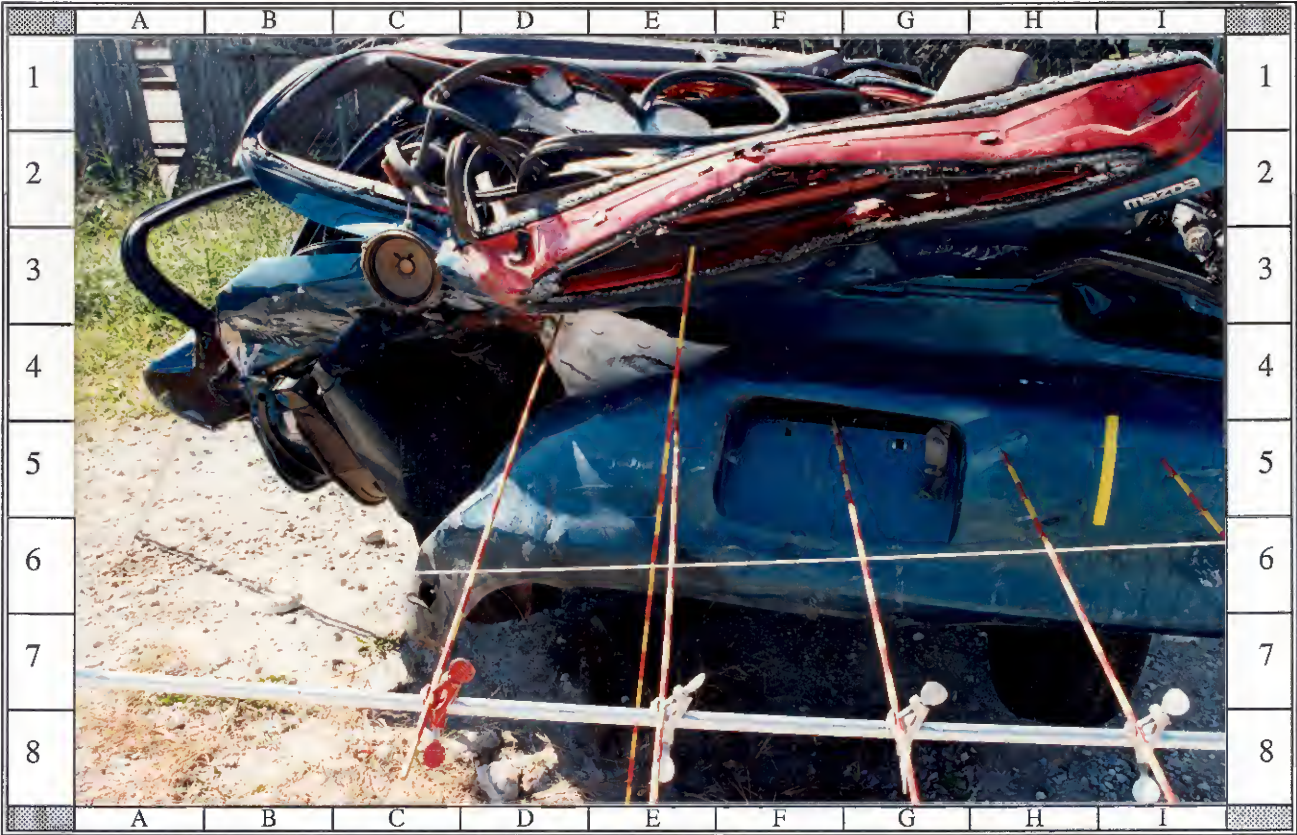
# 26: Case Vehicle's severely damaged back with contour gauge present

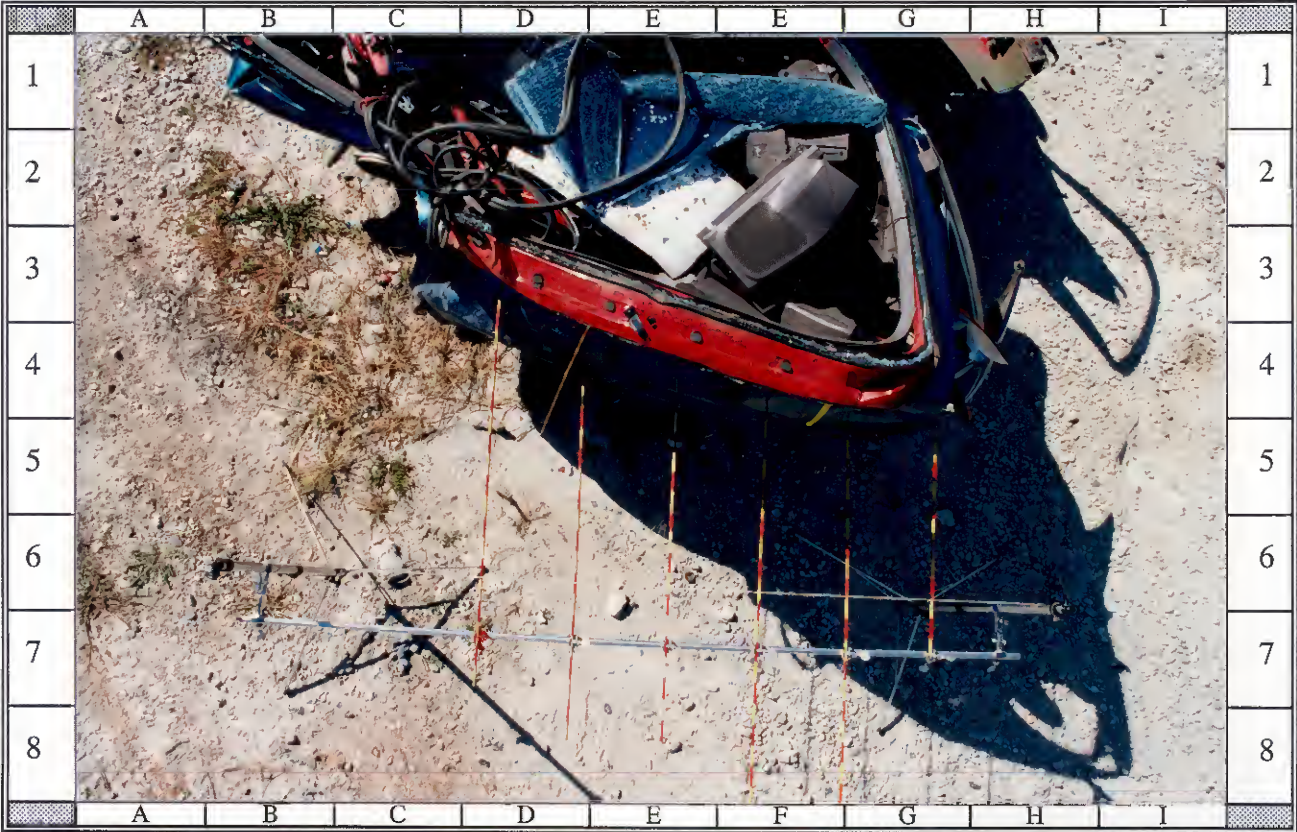
# 27: Close-up of direct damage to Case Vehicle’s back; NOTE: direct damage extends leftward from yellow tape to bumper corner

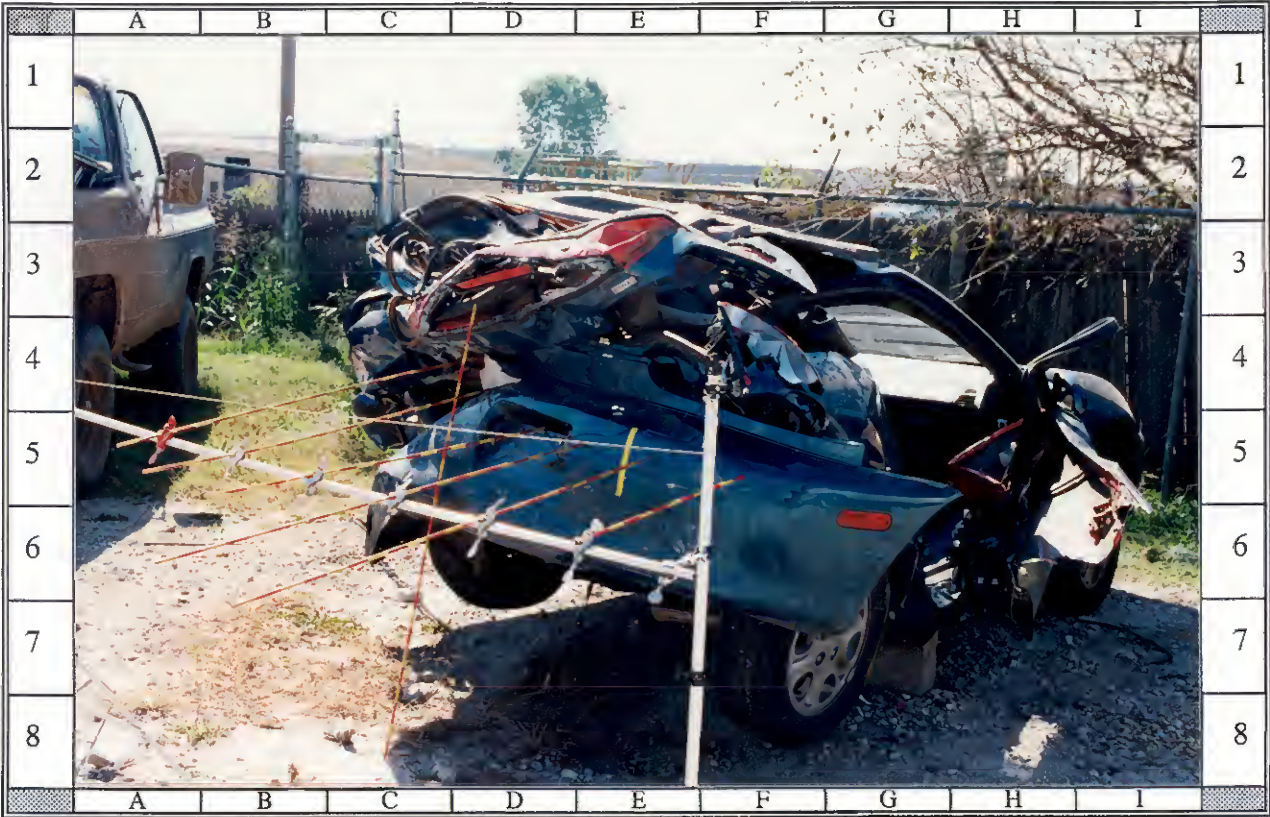
# 28: Overhead view of Case Vehicle’s damaged back showing extensive deformation, primarily to back left

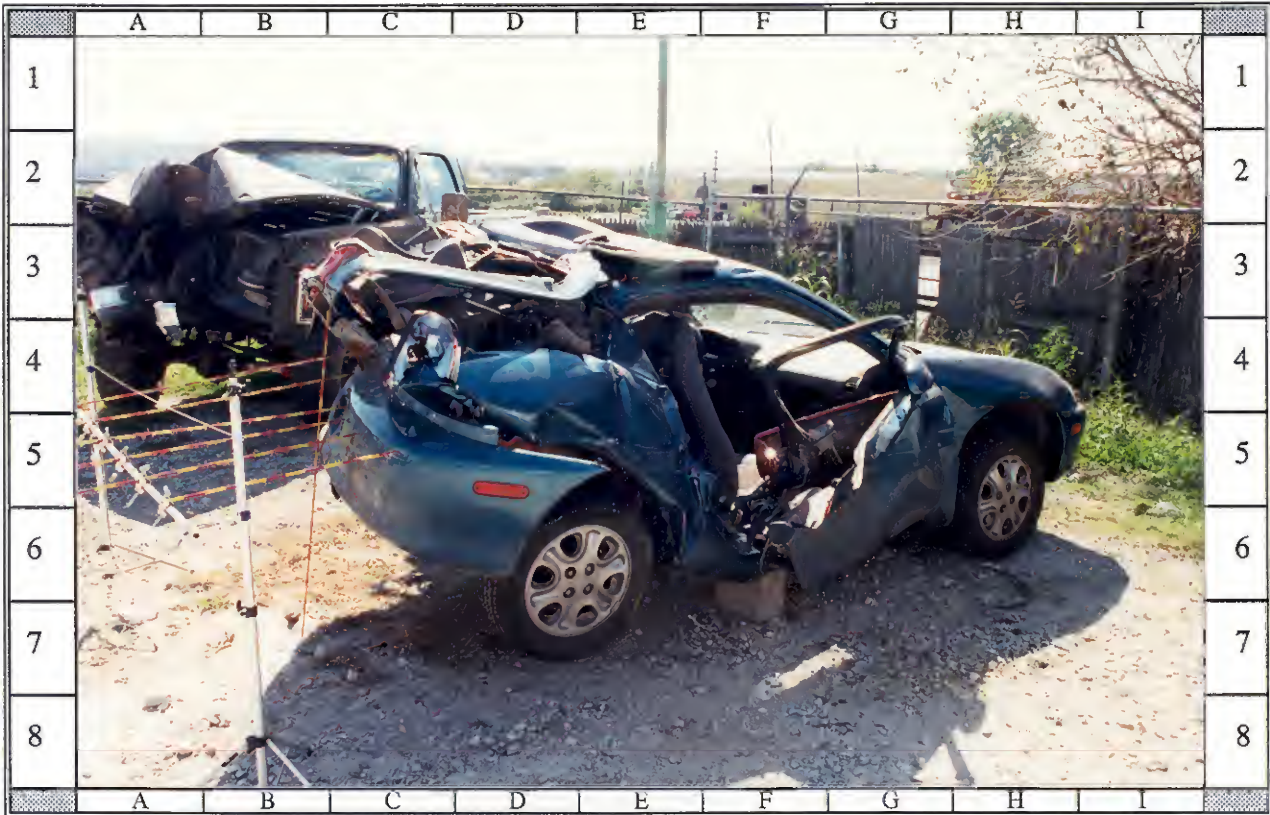
# 29: Case Vehicle's severely damaged back view from approximately 30 degrees right of back with contour gauge present

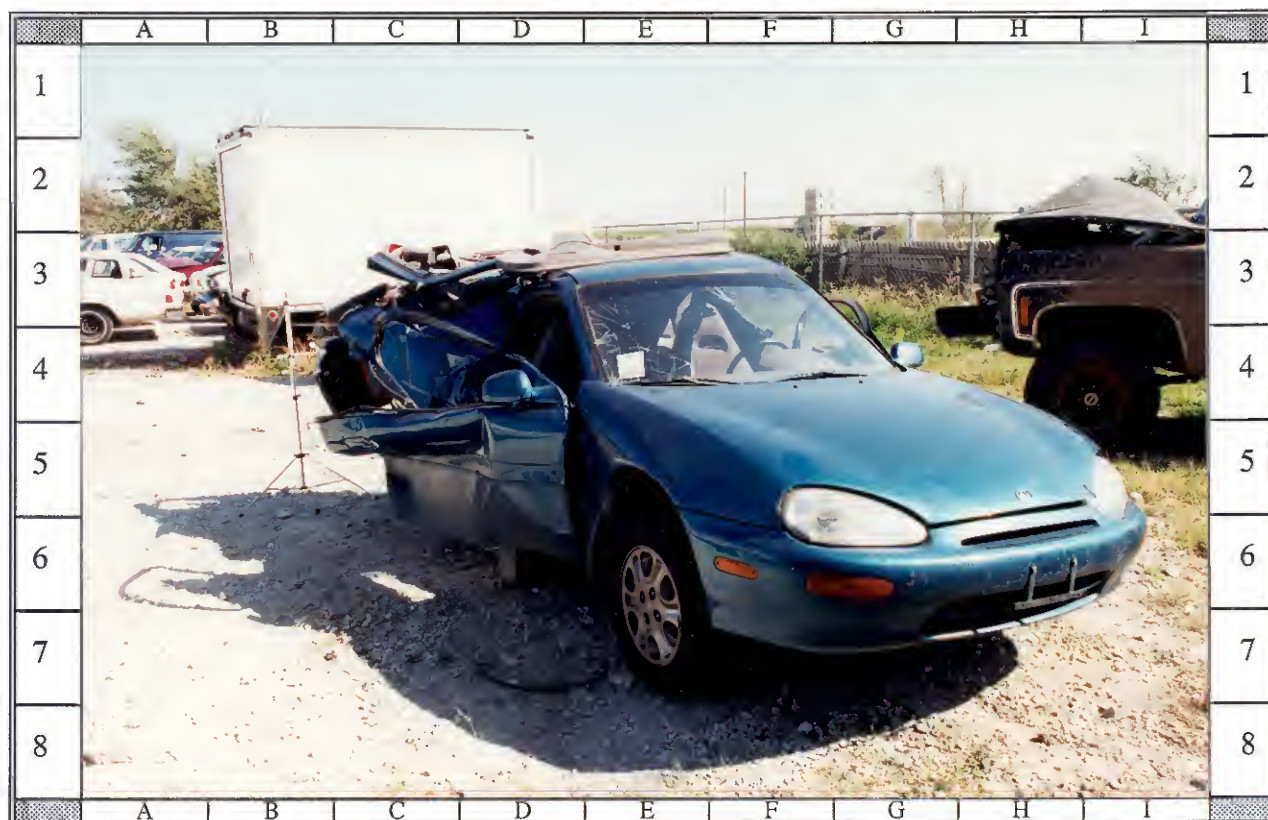
# 30: Case Vehicle viewed from approximately 75 degrees right of back showing extrication damage to right front door

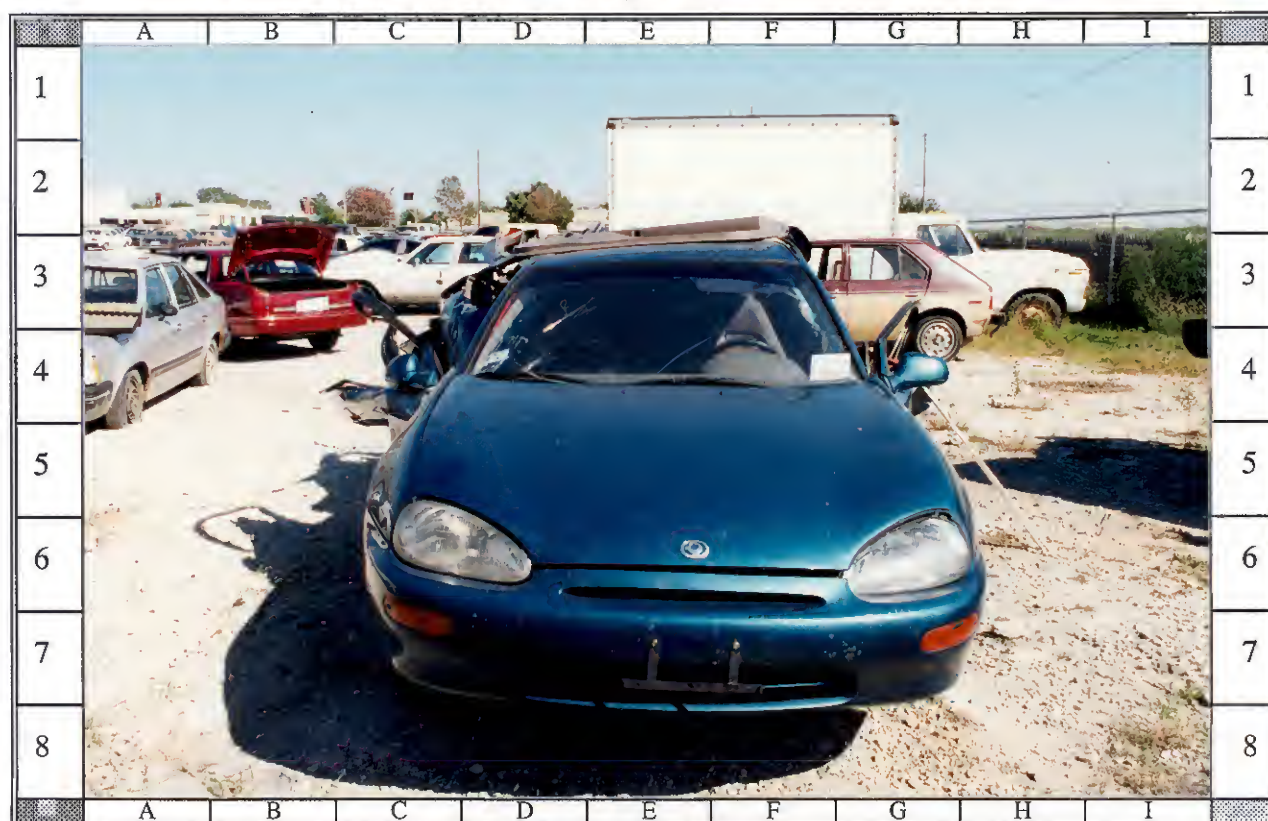
# 31: Case Vehicle's undamaged front viewed from ~45 degrees right of front; NOTE: crack to right lower windshield as passenger area was pushed forward into hood

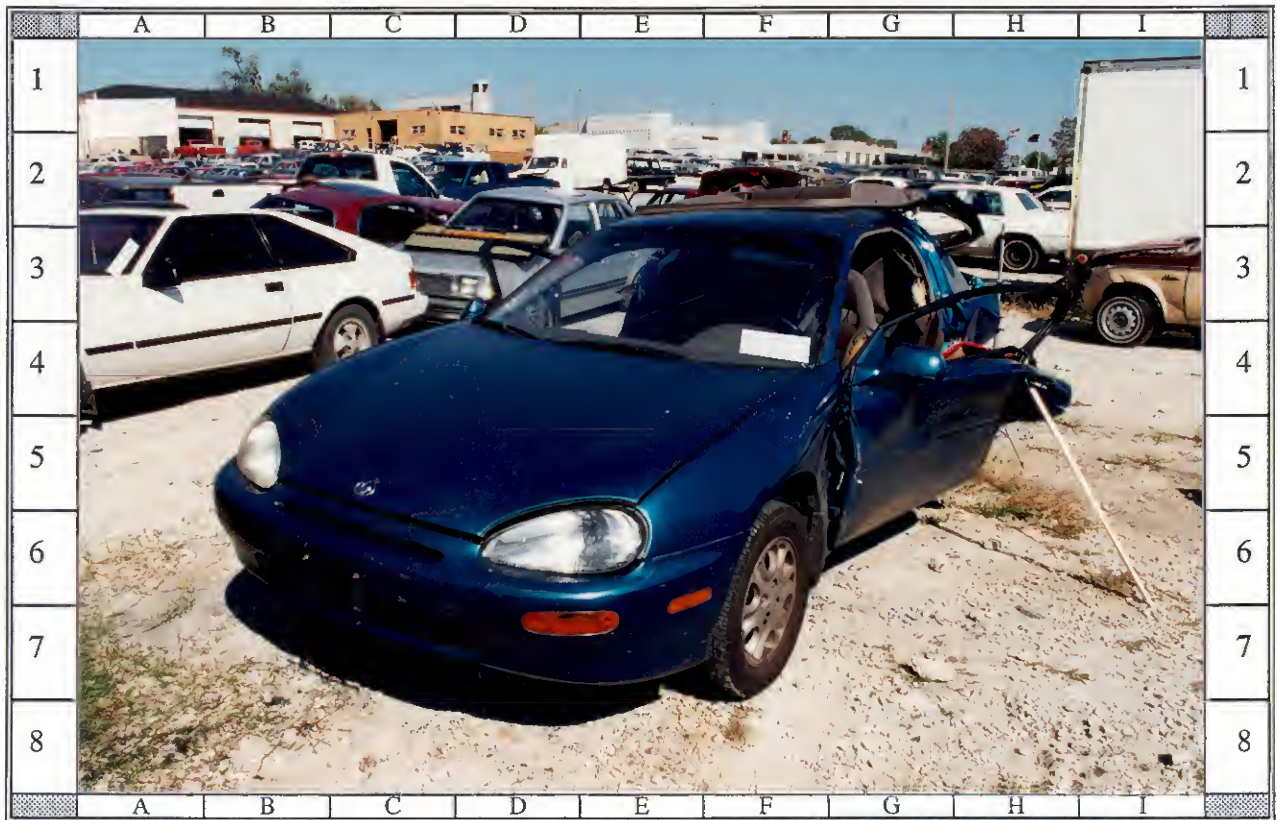
# 32: Case Vehicle's undamaged front; NOTE: stress fracture to right lower windshield caused by severity of crash

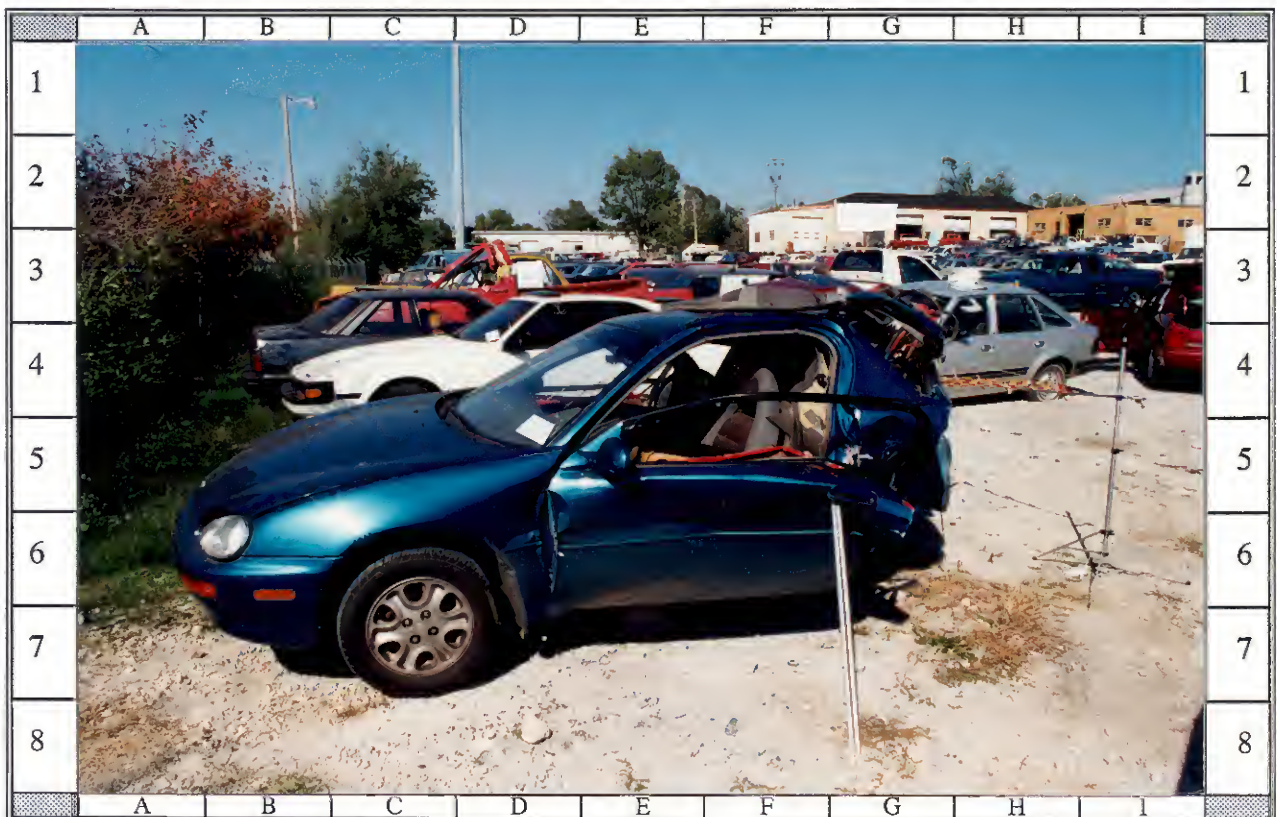
# 33: Case Vehicle's undamaged front viewed from ~30 degrees left of front; NOTE: extrication damage to driver's door and indirect damage to left fender

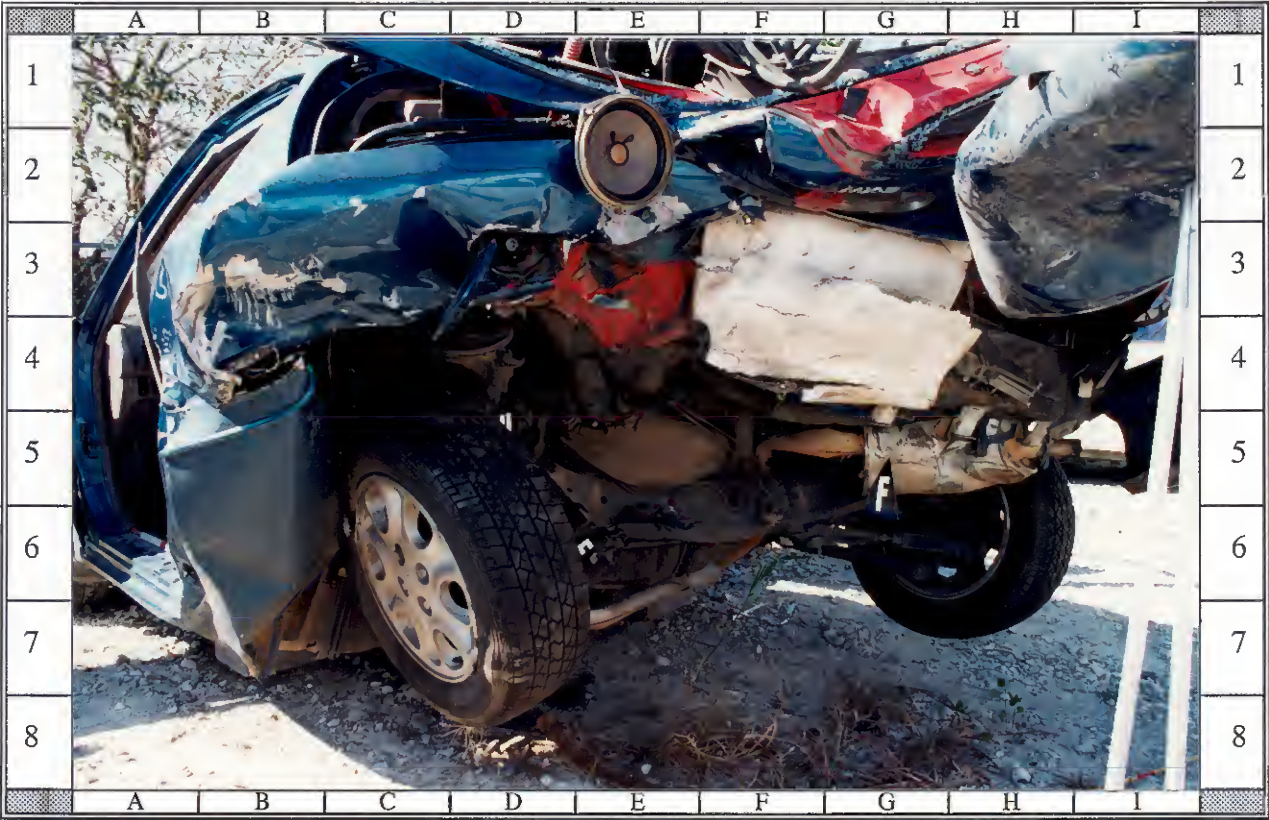
# 34: Case Vehicle's back damage viewed from left; NOTE: extensive crush to left rear corner

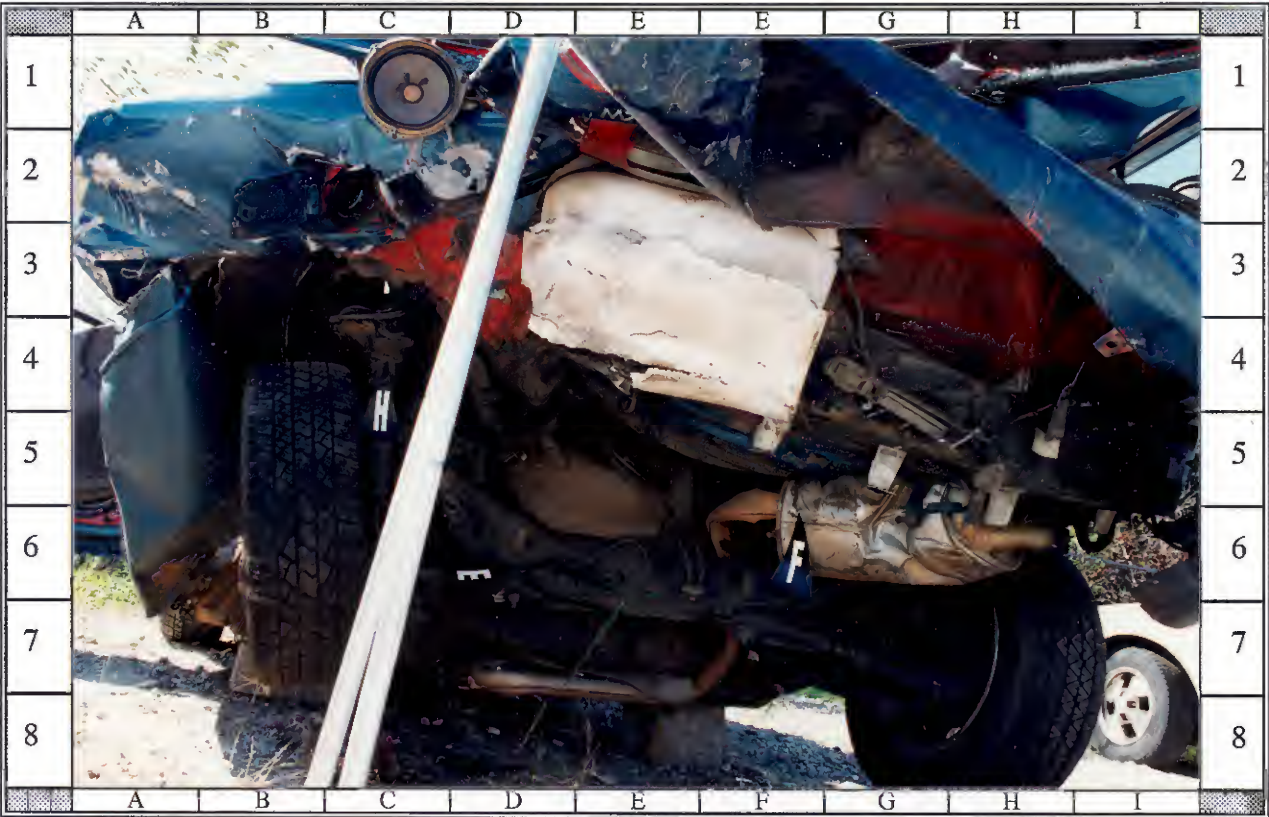
# 35: Direct damage to Case Vehicle's undercarriage viewed from ~15 degrees left of back without contour gauge present; NOTE: vertical component of crush

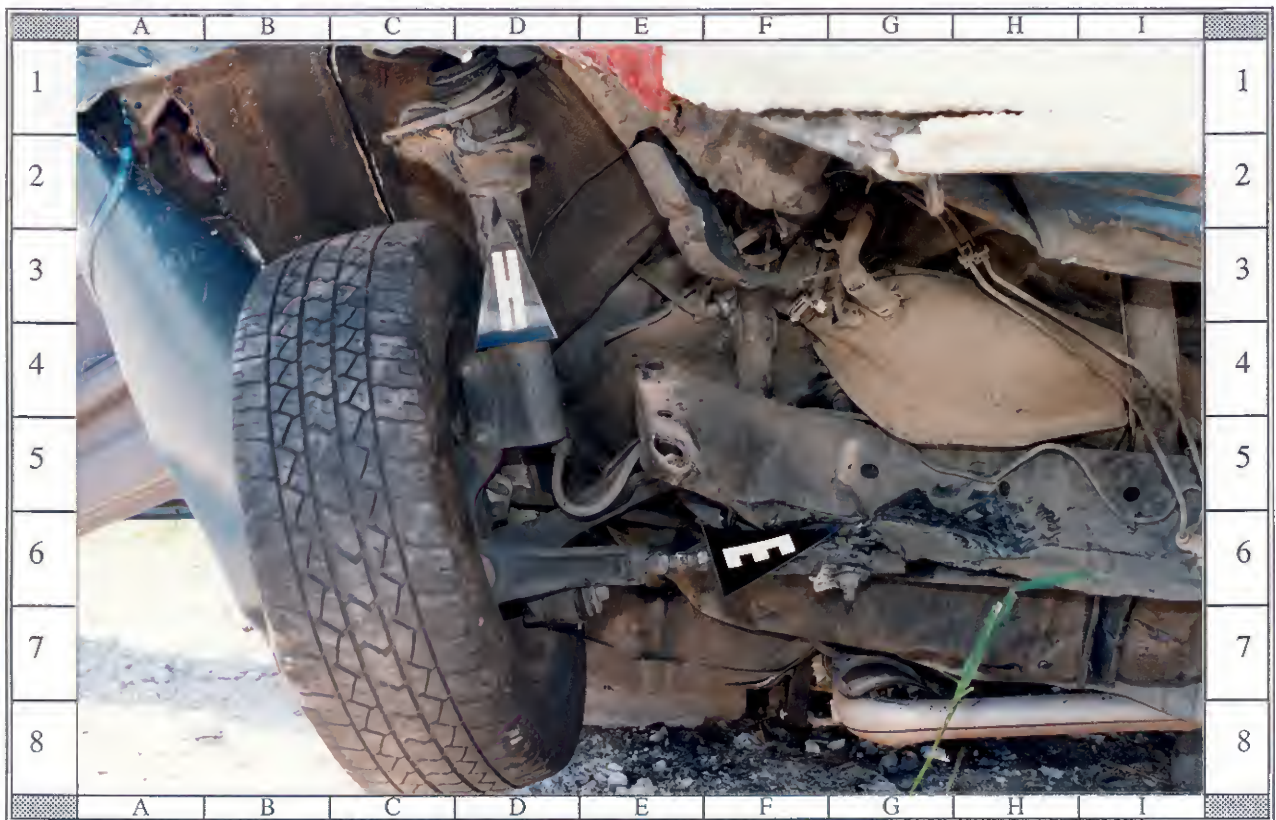
# 36: Close-up of direct damage to Case Vehicle's undercarriage showing vertical component of crush; NOTE: letters highlight contacted areas

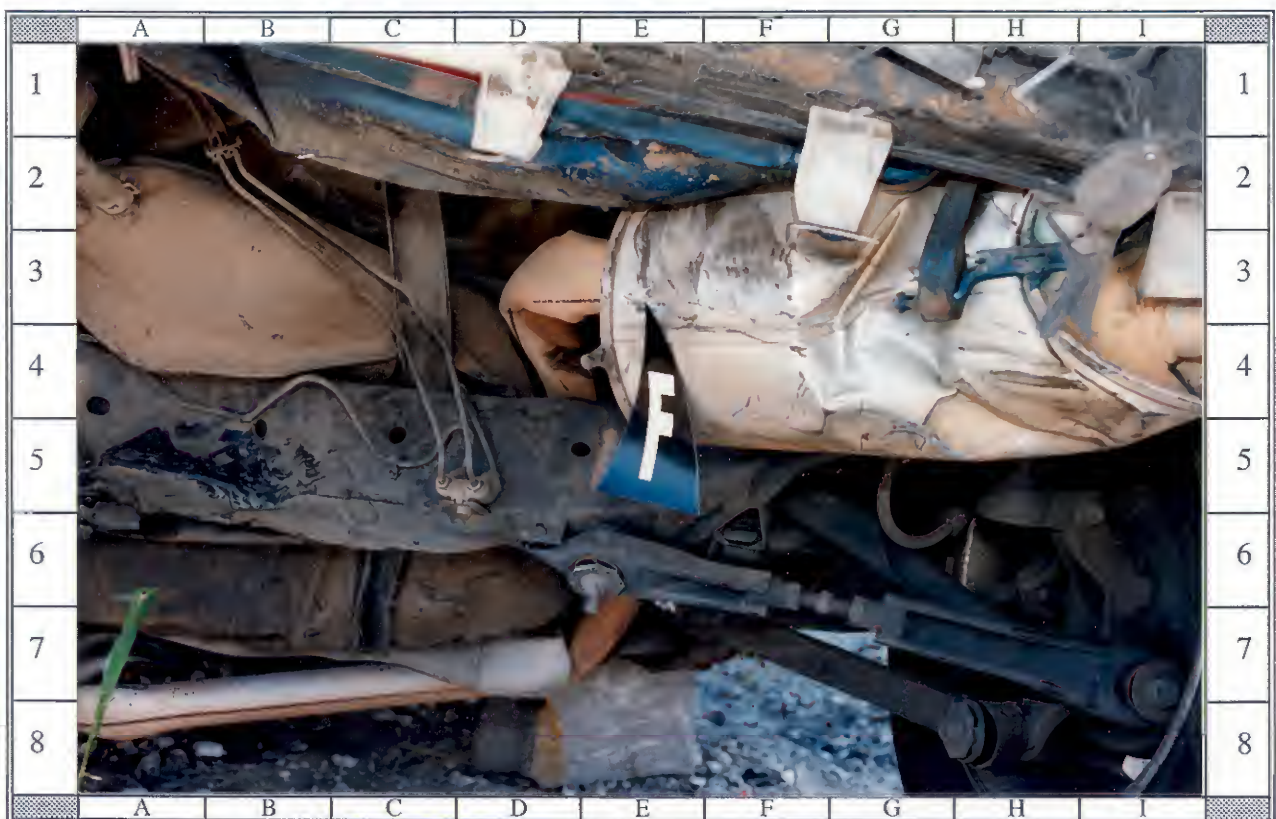
# 37: Closer-up view of direct damage to Case Vehicle's undercarriage (i.e., left rear strut "H" and rear cross member "E")

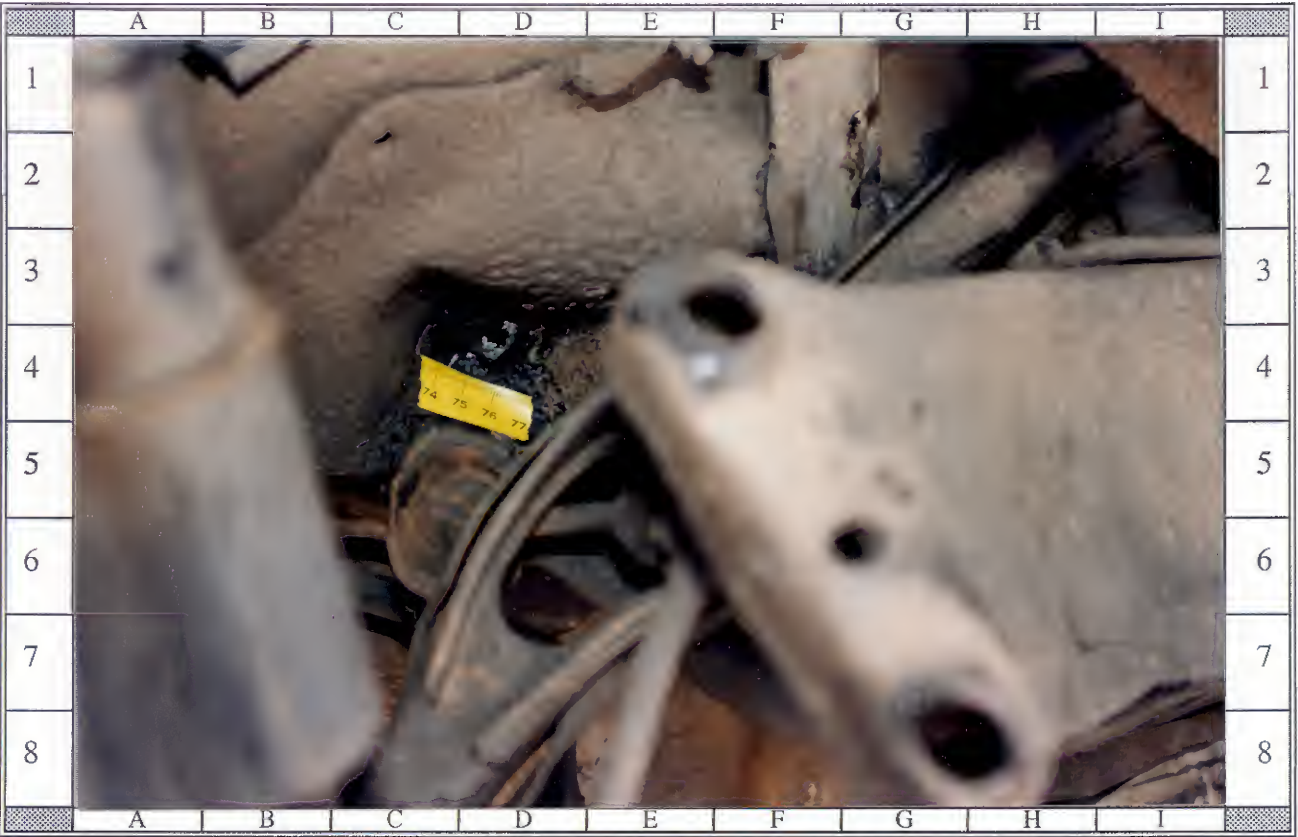
# 38: Close-up view of direct contact damage to Case Vehicle's undercarriage (i.e., muffler "F")

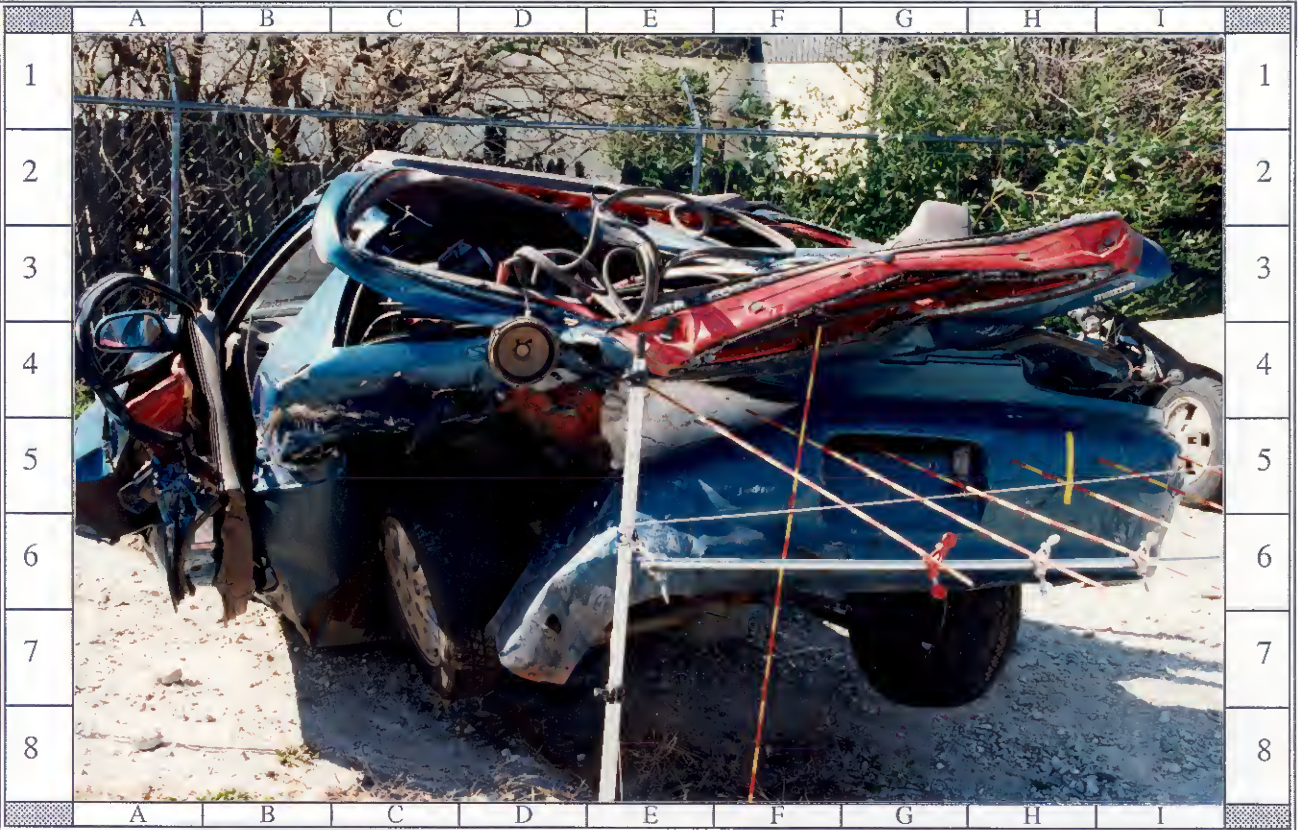
# 39: Closest-up view of puncture hole to Case Vehicle’s gas tank (i.e., yellow tape); compare with photograph #37 above

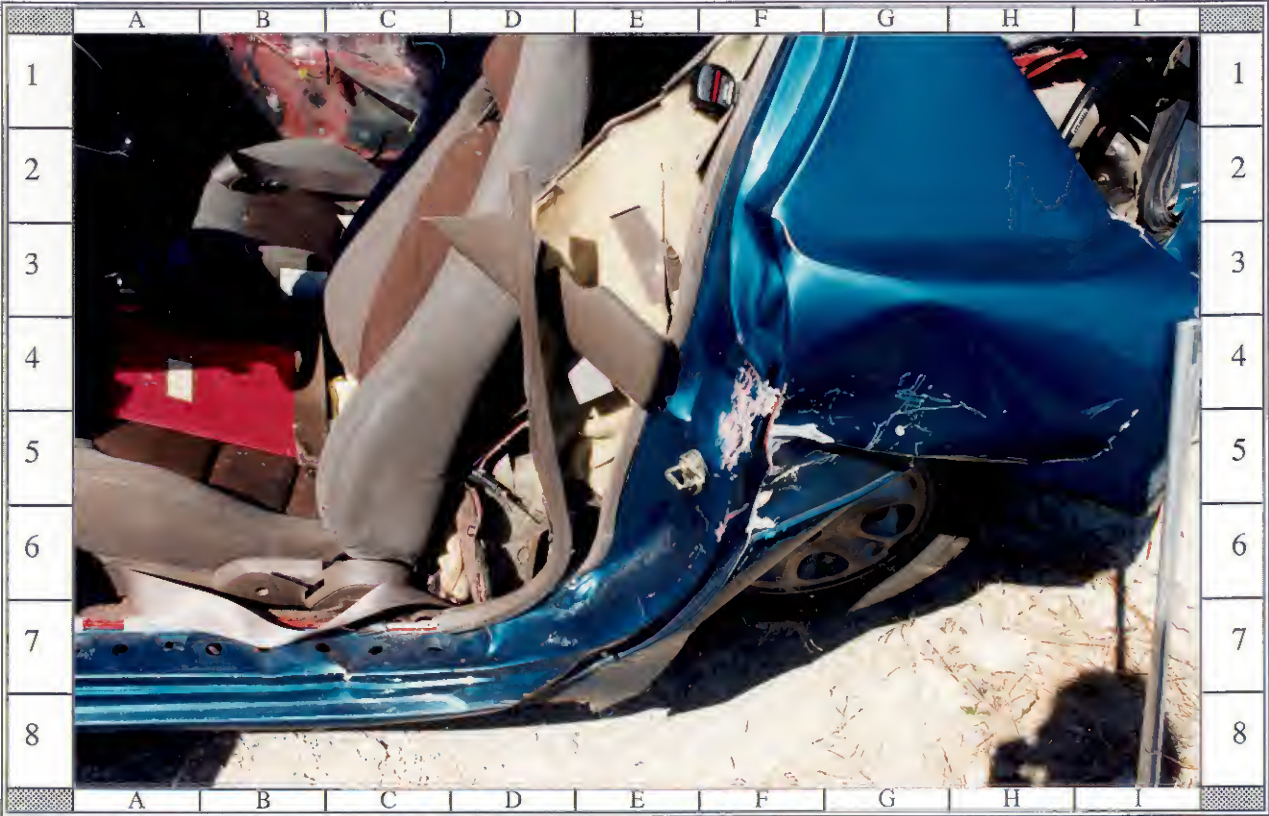
# 40: Case Vehicle’s damaged back viewed from approximately 15 degrees left of back with contour gauge present; compare with photograph #35 above

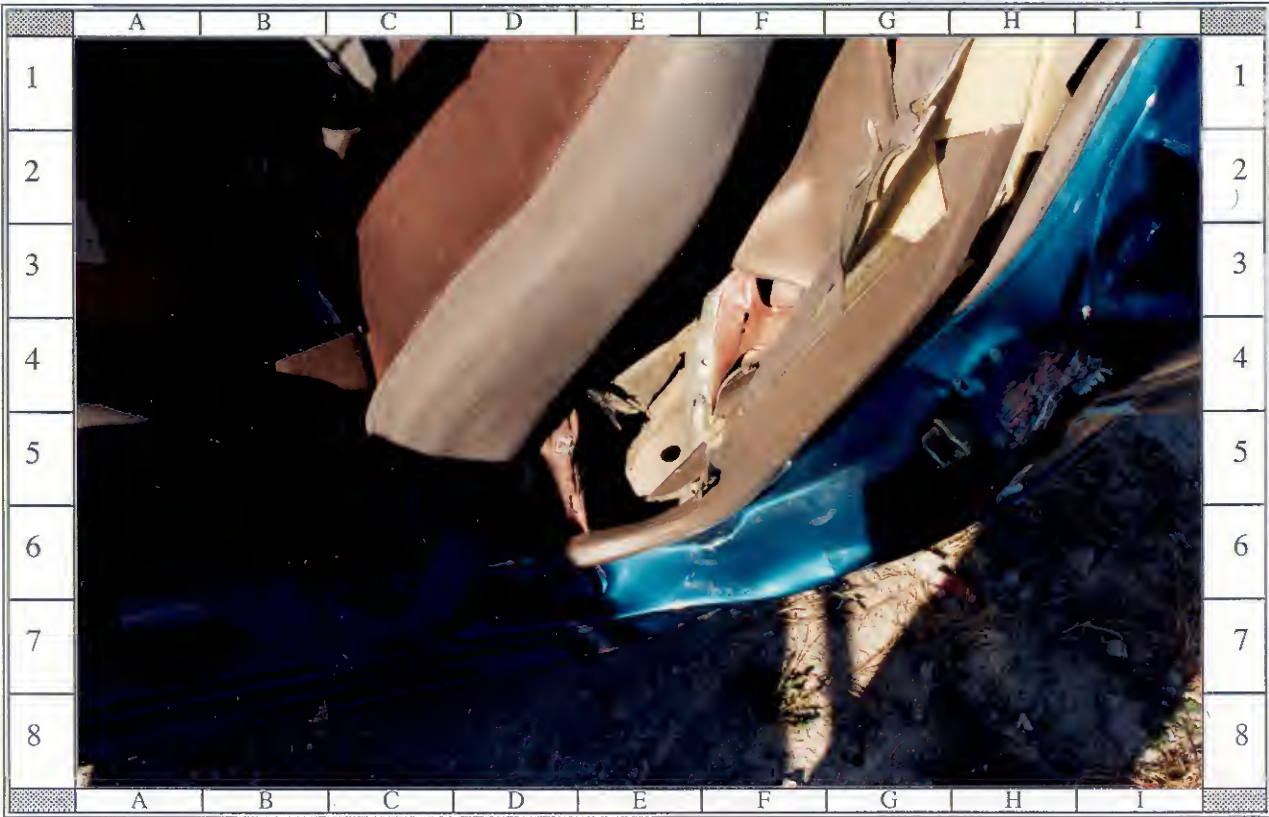
# 41: Case Vehicle's left door sill and left "B"-pillar area showing intrusion from left rear wheel; NOTE: extrication marks on door frame
